# **THE GREAT FLOOD OF 1993 POST-FLOOD REPORT**

## **UPPER MISSISSIPPI RIVER AND LOWER MISSOURI RIVER BASINS**

## **MAIN REPORT**

**SEPTEMBER 1994**

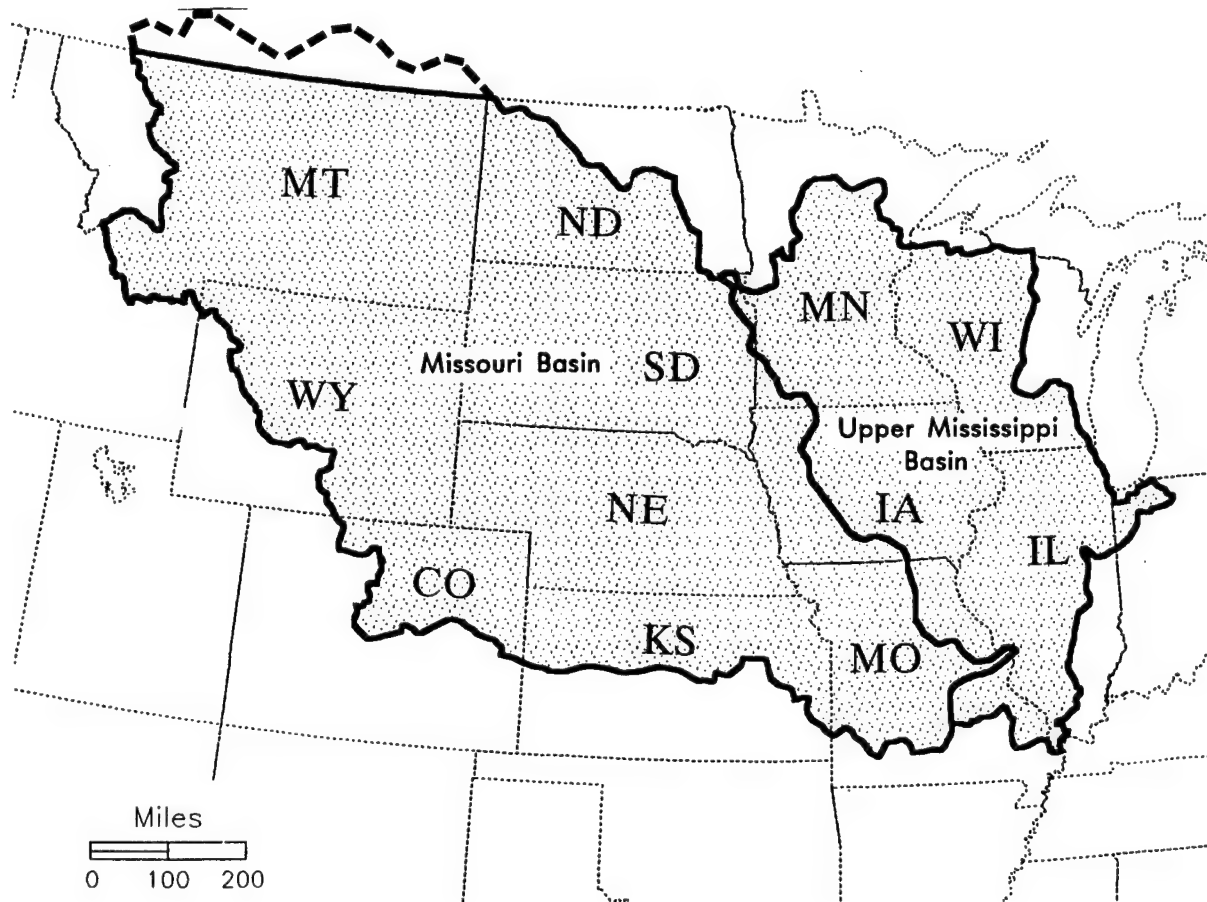
**Figure 1. Areal extent of the Missouri and upper Mississippi river basins.**

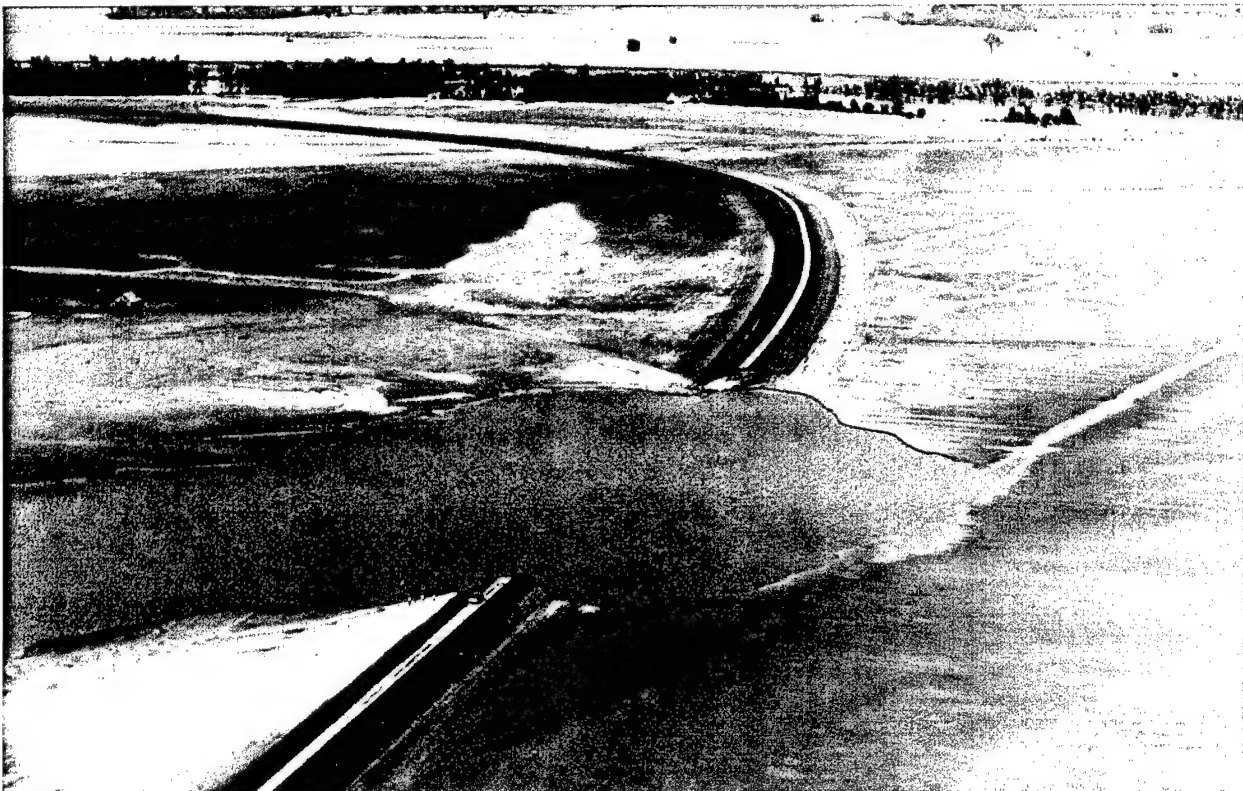
Levee breach at L470-460 near Elwood, Kan.

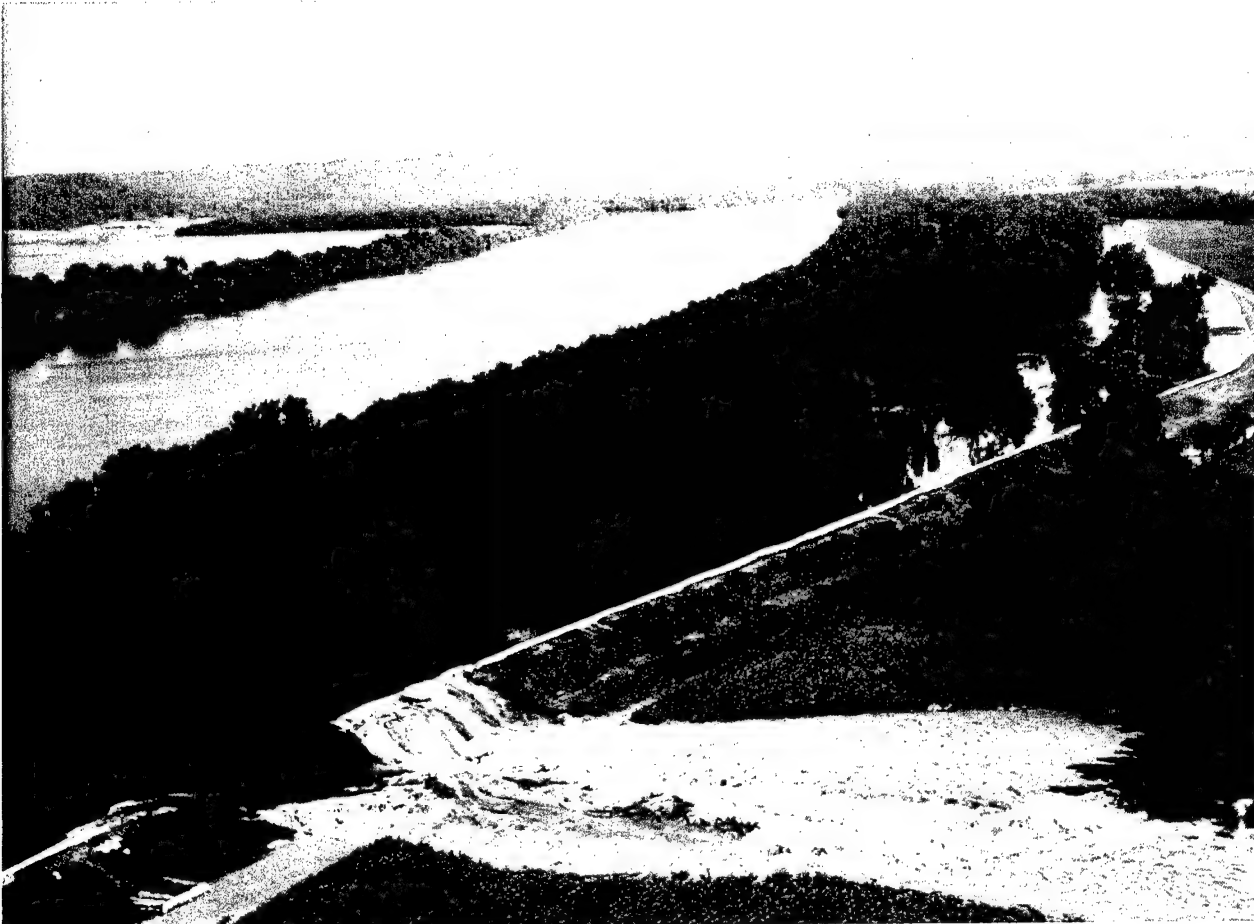
**Nutwood Levee break on the Illinois River.**

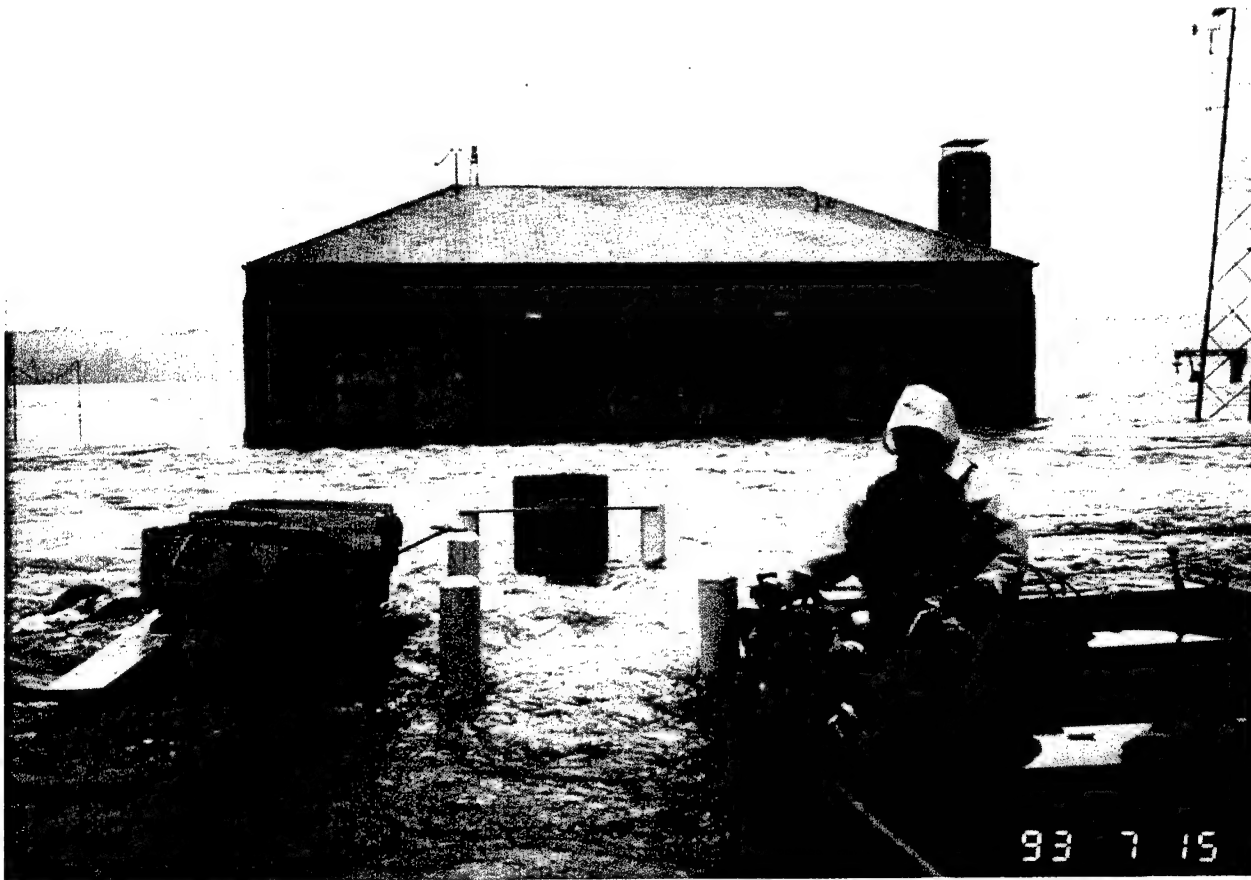
Flooded control house at Lock and Dam 21, Quincy, Ill.

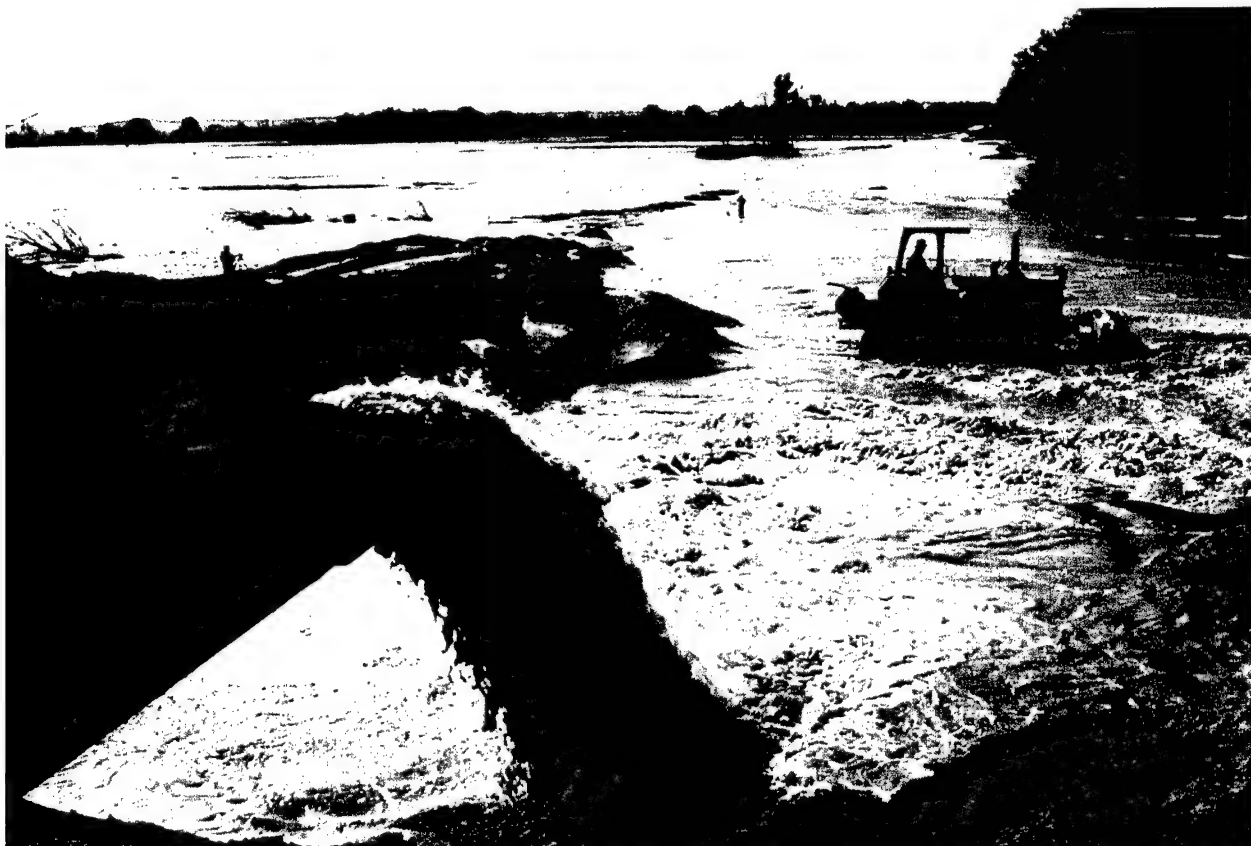
Hydraulic dredges repairing the damaged Sny levee.

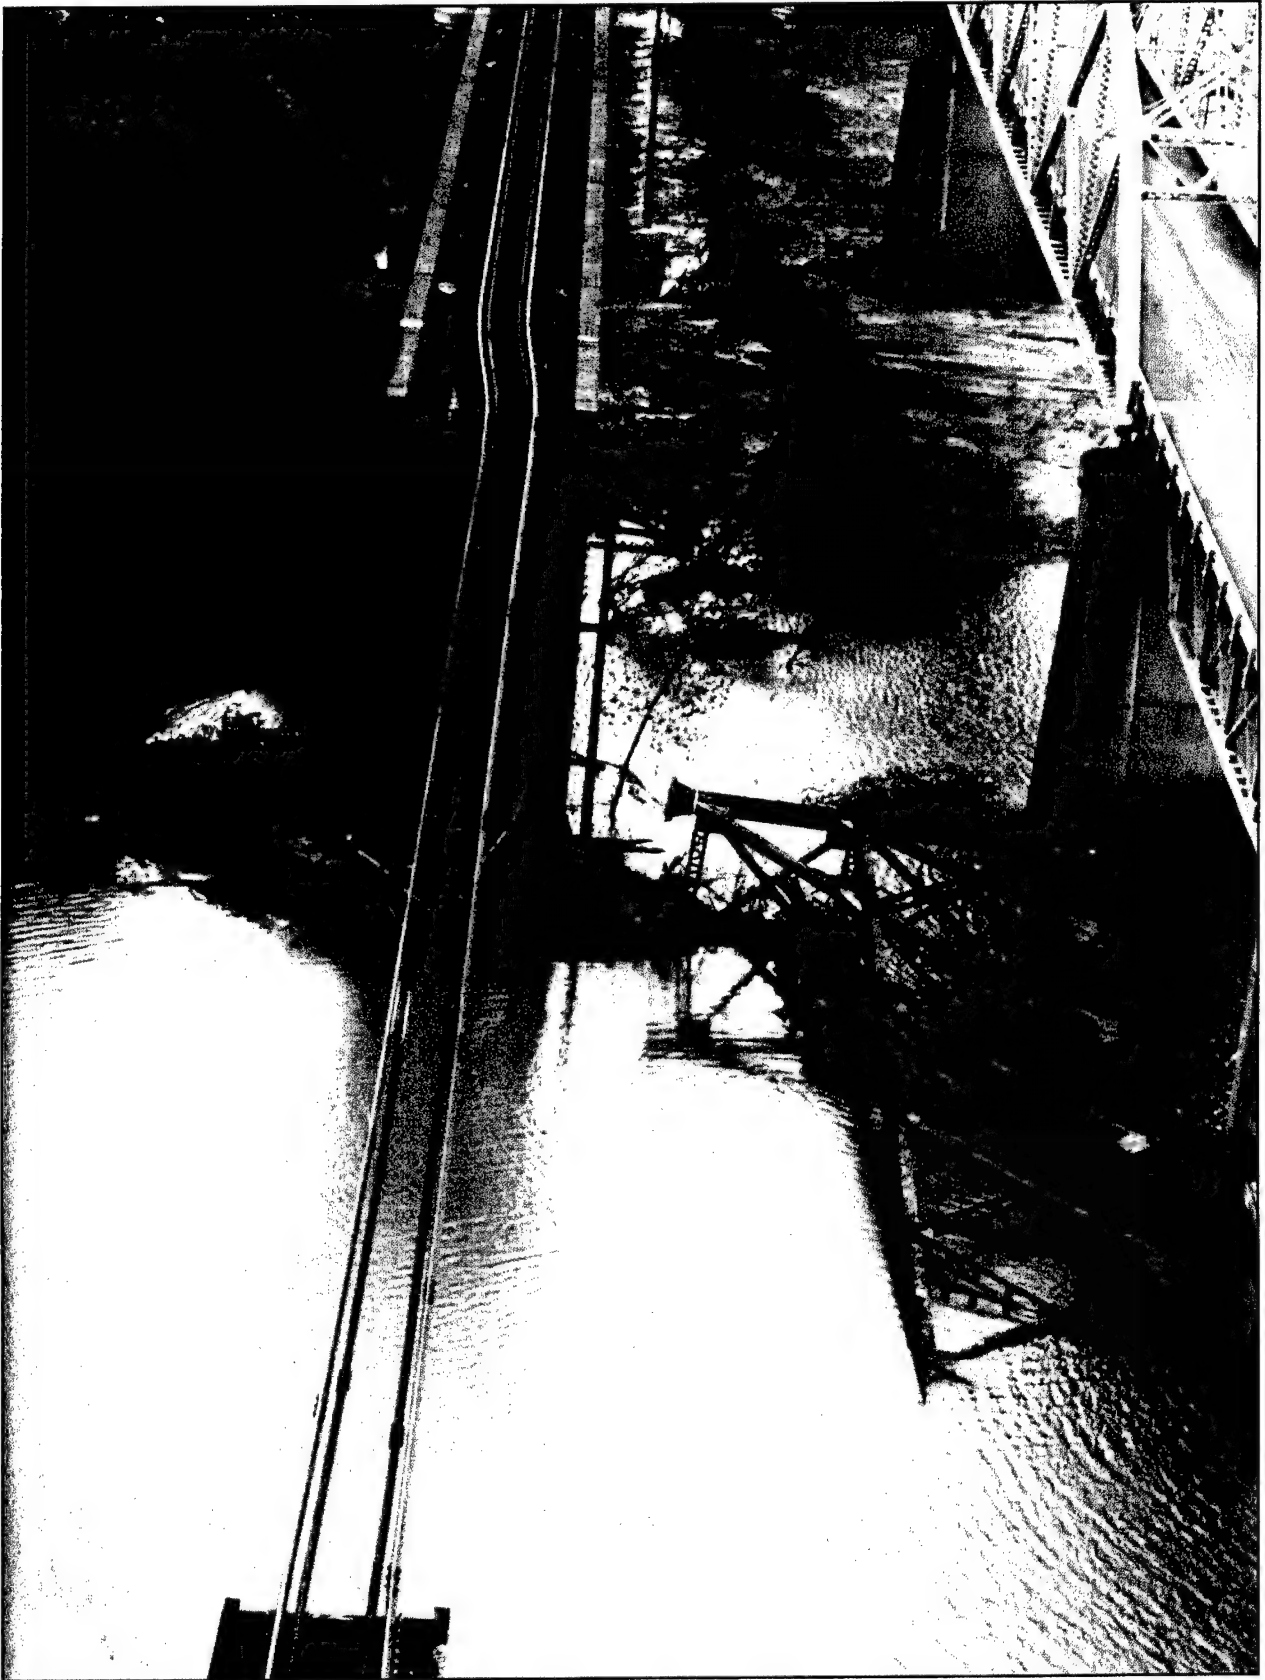
**Flooded railroad bridge over the Missouri River near Glasgow, Mo.**
